# Manhole Inspection Summary

Manhole # S29Q1\_024MH

Insp Date: **4/10/08 10:28 AM**

**Location** Address: **2814 Denham Cir. N.**

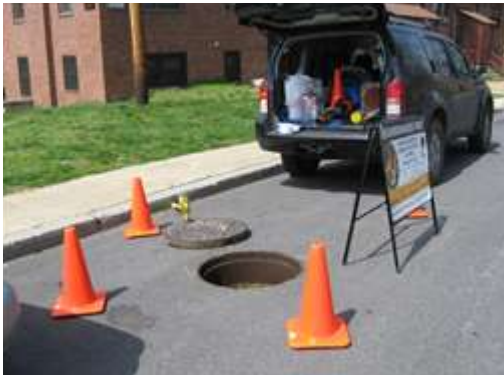
Location View

2814 Denham Circle N.

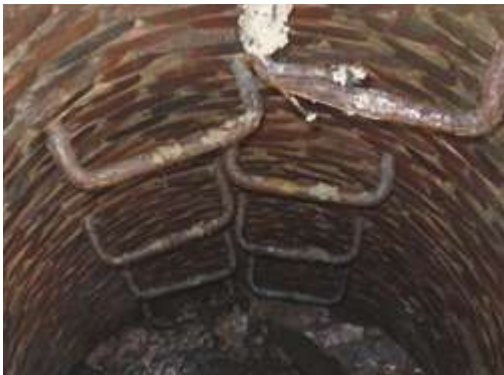
Steps

Count: **8** Missing: **0** ☒ **Corroded**

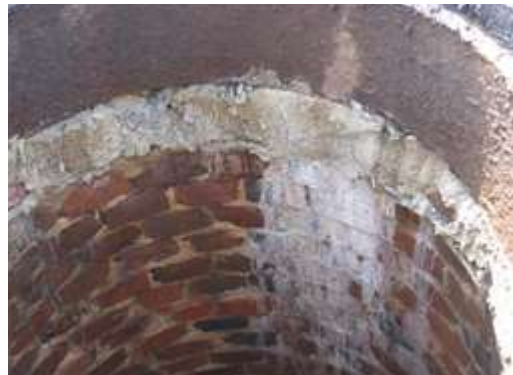
Defect 1

Condition: ☐ Sound ☒ **Cracked** ☐ Root Intrusion ☐ Loose Brick ☐ Deteriorated

Infiltration: ☐ None ☐ Joint ☐ Cracks ☒ **Mortar** ☐ Roots ☐ Wall

Mortar

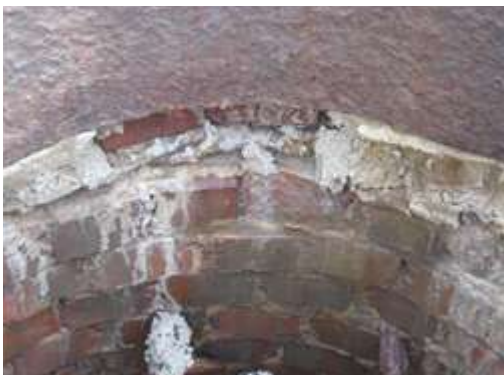
Defect 2

Frame-Chimney joint

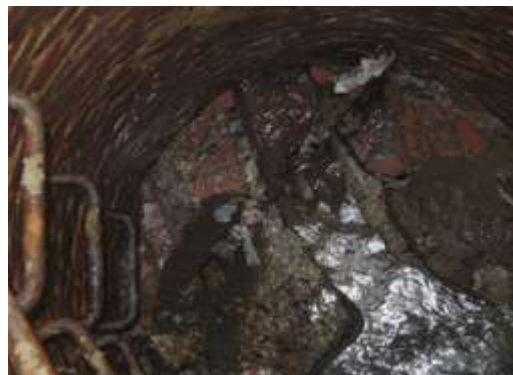
Defect 1

Condition: ☐ Sound ☐ Cracked ☐ Root Intrusion ☐ Deteriorated ☐ Leaks ☒ **Debris**

Foreign objects and debris

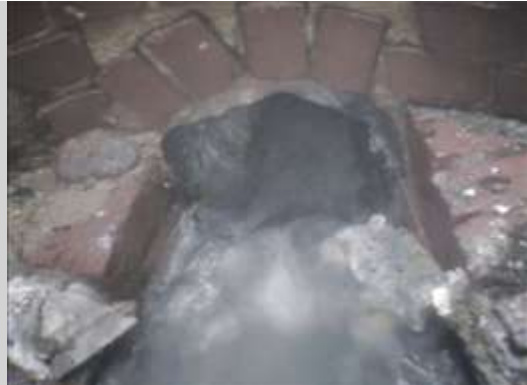
12 O'Clock Outflow

10 in. Circular Gravity Sewer  
Pipe Out @ 12 O'Clock

Pipe Height: **13.2** (in.) Rod and Bar (Angled)  
Pipe Material: **Clay** ☐ Pipe Lined  
Invert Depth: **13.78** (ft.) Flow Characteristics: **Fast**  
Deposits: ☒ None ☐ Mud ☐ Sludge ☐ Debris ☐ Grease  
Silt Depth: (in.) Deposits Extent:  
Infiltration: **None** Pipe Seal Cond: **Sound**

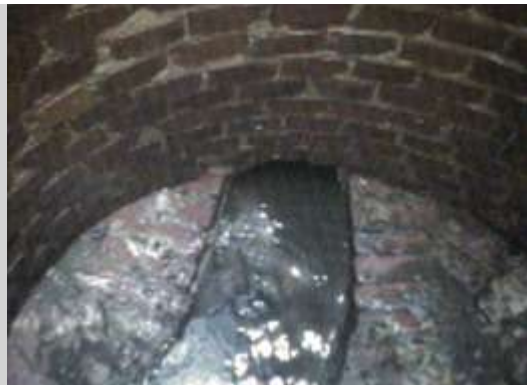
4 O'Clock Inflow

10 in. Circular Gravity Sewer  
Pipe In @ 4 O'Clock

Pipe Height: **10.8** (in.) Rod and Bar (Angled)  
Pipe Material: **Clay** ☐ Pipe Lined  
Invert Depth: **13.67** (ft.) Flow Characteristics: **Fast**  
Deposits: ☒ None ☐ Mud ☐ Sludge ☐ Debris ☐ Grease  
Silt Depth: (in.) Deposits Extent:  
Infiltration: **None** Pipe Seal Cond: **Sound**

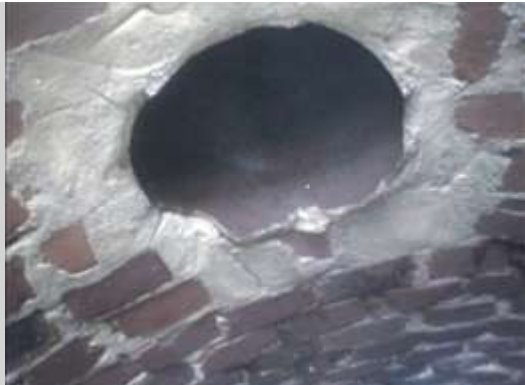
8 O'Clock Inflow

Pipe In @ 8 O'Clock

Pipe Height: **8.4** (in.) Rod and Bar (Angled)

Infiltration: **None** Pipe Seal Cond: **Sound**

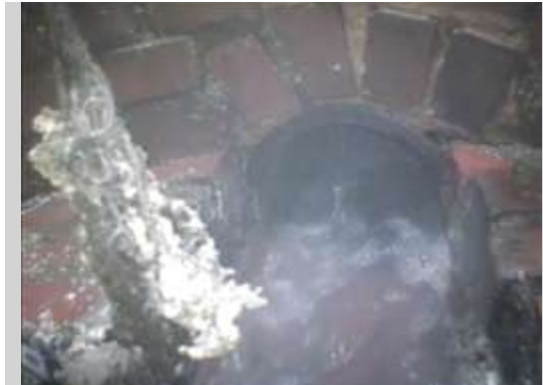
Drop In @ 8 O'Clock

Drop: **Outside** Rod and Bar

Angled: **Yes** Reading: **12.55** (ft.)

Inv Depth: **13.55** (ft.)

Drop Condition: **Open**
